Ref:
10717IDEN

RE: PROPERTY NO. 5 RONALD AVENUE HARBORD

As instructed by you and on your behalf I have surveyed for identification purposes the above described land further shown edged red in attached plan dated 7th December, 1999.

STRUCTURAL ASSESSMENT.
5 RONALD AVENUE, HARBORD.

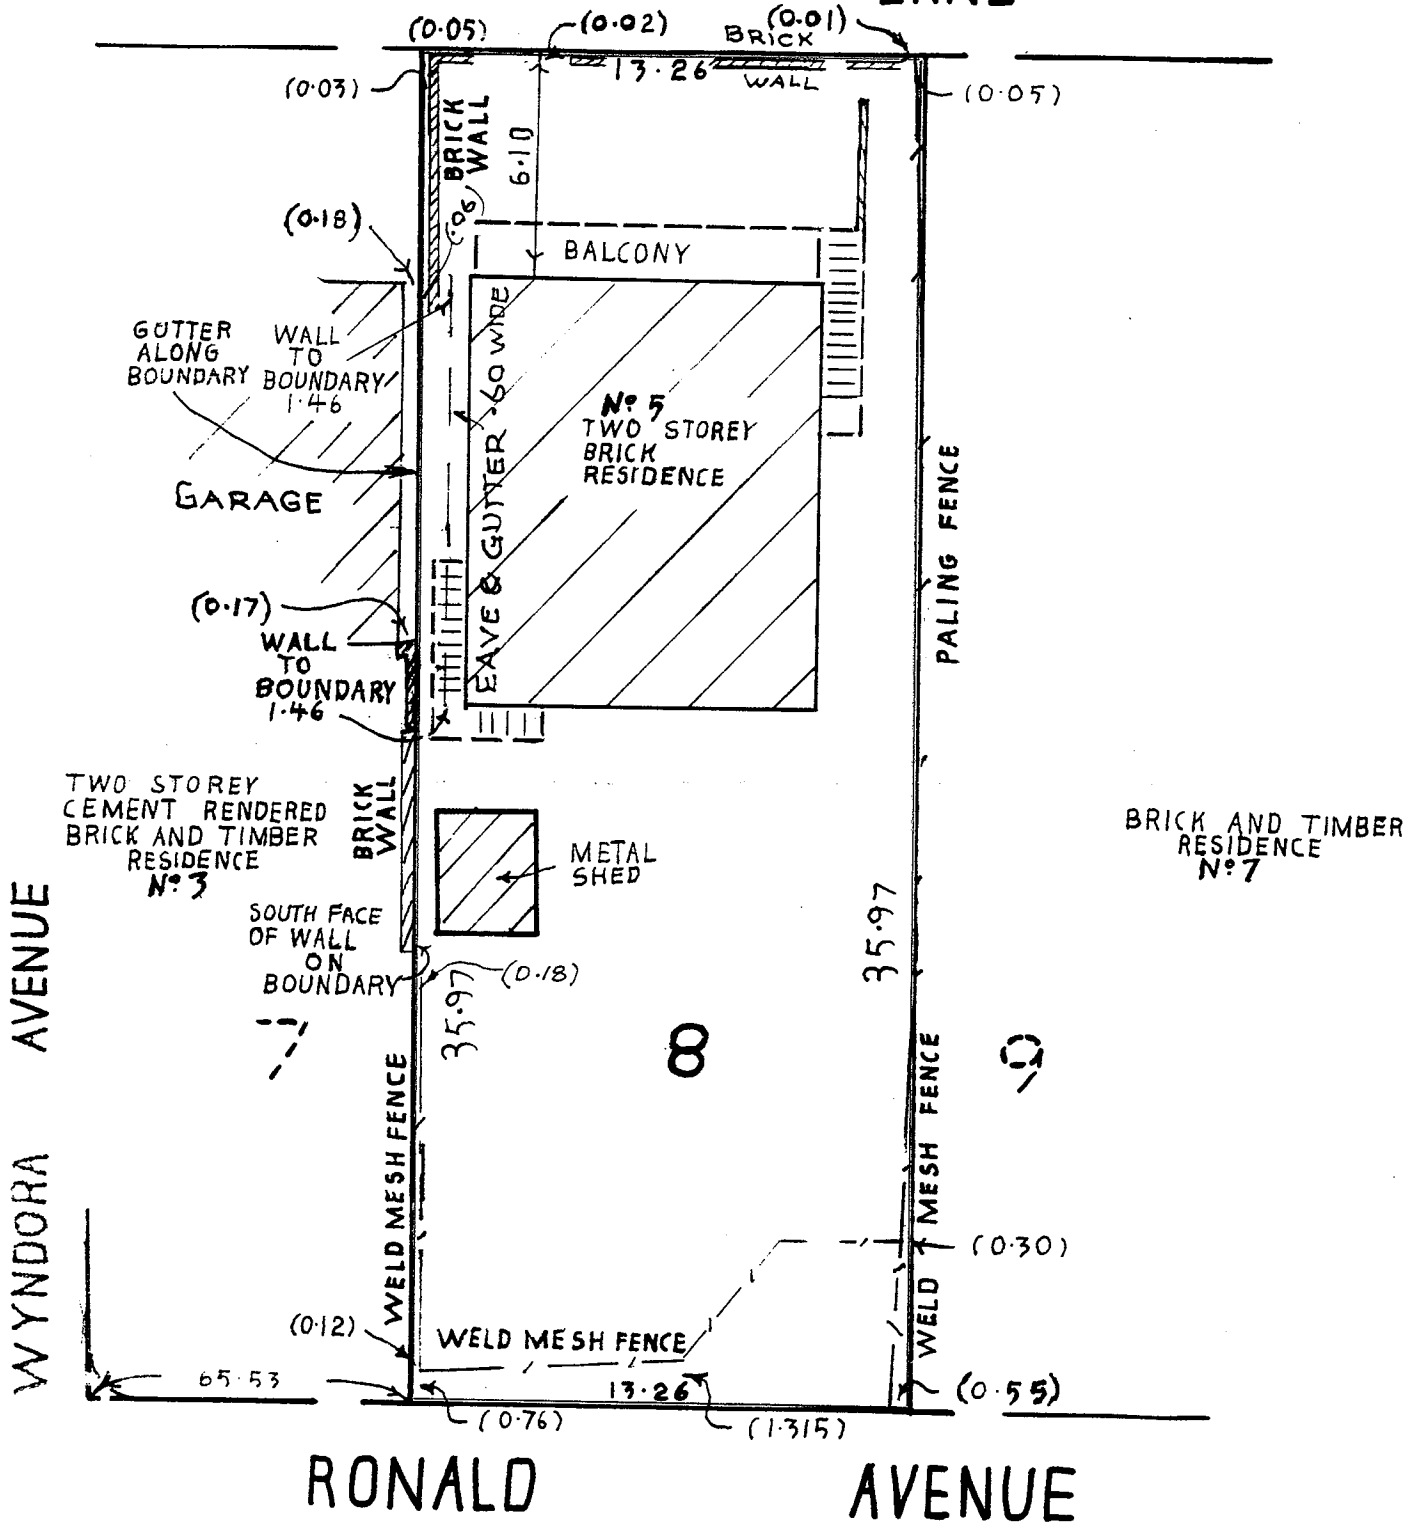
Upon the land stands a two storey brick residence with a tiled roof and it is known as No. 5. The location of the main wall relative to the nearest boundary is as indicated in plan.

Near the north west corner of the lot a weld mesh fence stands up to 0.76 off the street and up to 0.12 upon subject land.

Near the south western corner of the lot a weld mesh fence stands up to 0.55 upon subject land.

The boundaries of the land are fenced as shown in plan and other than as stated above and minor irregularities in fencing there are no visible encroachments by or upon subject land.
